# Spectral Enhancement and Automated Extraction of Potential Sinkhole Features from NAIP Imagery – Initial Investigations

J. S. Dinger<sup>1\*</sup>, D. P. Zourarakis<sup>2</sup> and J. C. Currens<sup>1</sup>

<sup>1</sup>Kentucky Geological Survey, University of Kentucky, Lexington, KY, 40506-0107 USA

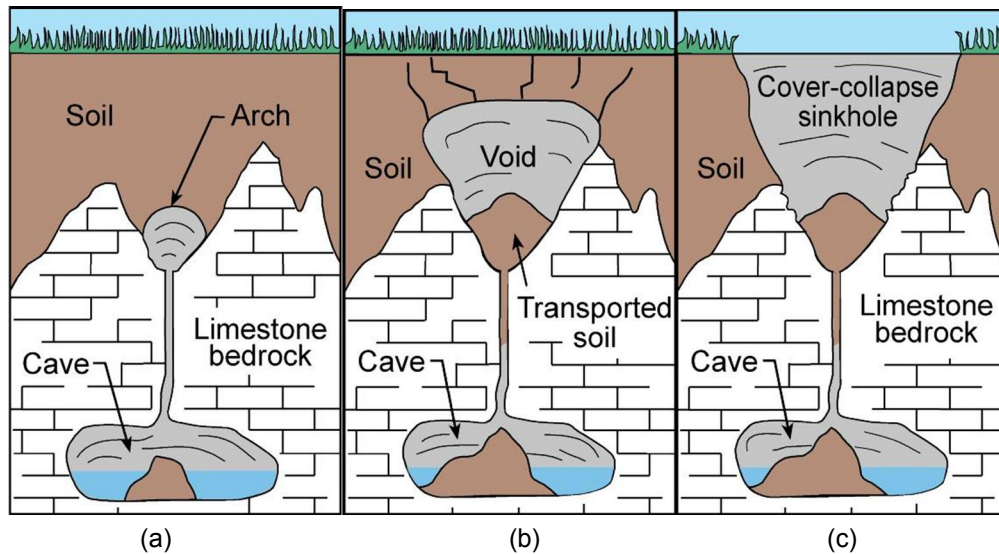
**Figure 2.** Sequence of bedrock dissolution leading to land-surface cover collapse that forms a sinkhole.

Figures 2a through 2c are schematics depicting the sequence of how cover-collapse sinkholes develop in a process caused by erosion of the soil arch above a solution feature in the bedrock. Figure 2a shows the beginning of the development of subsurface soil erosion at the top of a dissolution conduit in the bedrock. Either water moving down through the soil profile to the bedrock or a rise in groundwater upward through an existing cave passage weakens the soil which begins to slump down through the bedrock forming a void in the soil. As this process continues through time, the soil void continues to grow upward and eventually leave a thin soil arch above the void (Figure 2b). Ultimately, this soil arch becomes so thin that it does not have the strength to support itself, and cover collapse occurs to form a sinkhole (Figure 2c). The length of time for this sequence to occur is undetermined but we estimate that the latter two stages can be rather rapid, potentially within a few years, depending on many hydrogeologic variables such as soil type, amount of rainfall infiltration, and fluctuation in the water table. Typically in the eastern portion of the USA, cover-collapse sinkholes range in diameter from 0.5 meters up to tens of meters, and can range from one meter to fifteen or more meters in depth.

A cost-effective method for early identification of potential sinkhole sites would be a tremendous benefit to land-use planners, agriculturists, and environmentalists. The purpose of this current research is to develop a methodology to use the remotely sensed imagery to predict future sites of sinkhole development. In addition to observable, mapped or unmapped sinkholes, it is our hypothesis that the beginning stages of formation of these features may be observable on satellite and airborne images because of the seasonal moisture stress they exert on vegetative cover over the soil arch (Figure 2b).

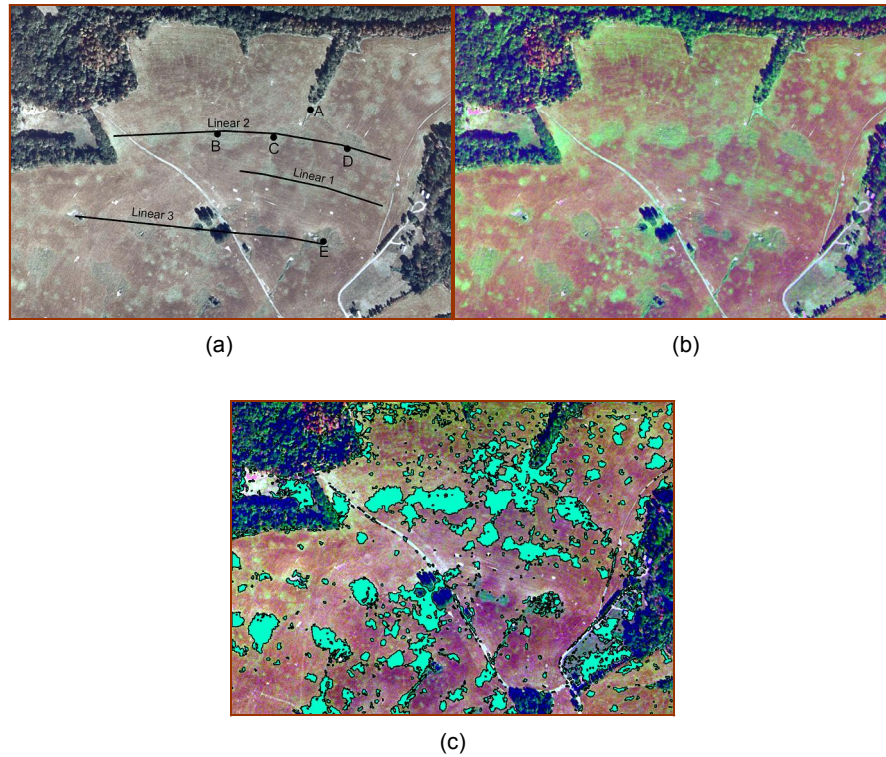
**Figure 4.** (a) Original NAIP imagery with linears; (b) Decorrelation-stretched image; (c) Extracted feature layer on the Newton farm.

Two images of the Newton Farm, original RGB NAIP and spectrally enhanced are shown in Figures 4a and 4b, respectively. Prominent, circular shapes stand out. The software used to extract feature layers from the imagery, Feature Analyst™ 4.0 extension for ArcGIS™ 9.1, was “trained” by a human analyst on a very small subset of features visible on the decorrelation-stretched image. The software, which operates on the base of proprietary, heuristic learning algorithms, was run utilizing a Manhattan input representation with a 13-pixel pattern width. The resulting output, a polygon feature layer shown in Figure 4c, retains the pattern revealed in the source image.

The most predominant circular shapes are light green. These circular shapes have a rather consistent diameter ranging from approximately 25 to 45 m. Two groups of these circulars appear to form curvilinear patterns in some portions of the image to form lineaments. Both lineaments trend west-north-west (see Figure 4a, Linears 1 and 2). The less predominant circular shapes are brown-green in color and they also form a linear in the same geographical orientation (see Figure 4a, Linear 3).

Linear 2 is a low lying area on which surface water drains from the field toward and then down the north trending, narrow, steep-sloped surface drainage bordered by trees (see Figure 4a, point A). There are several shallow depression along the Linear 2 (see Figure 4, features B, C, and D), and a narrow erosion furrow between features B and C with a noticeable knick point (Figure 8) However, there is no appearance of sinkhole development along this linear nor were any epikarst swallow holes observed.

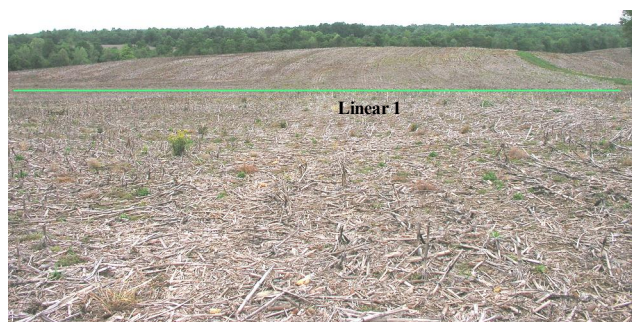
**Figure 5.** Photograph of corn stubble and Linear 1 on Newton farm.

The two linears formed by the light-green circular shapes have different topographic settings. Linear 1 parallels a moderate slope and represents a slight leveling of this slope to form a semi-flat surface (see Figure 5). Its surface has occasional epikarst swallow holes approximately 2.5 to 6 cm in diameter (Figure 7). However, there is no confluence of surface-water drainage to provide any sort of a semblance of sinkhole development like that described above along Linear 3 (see Figures 4 and 6).

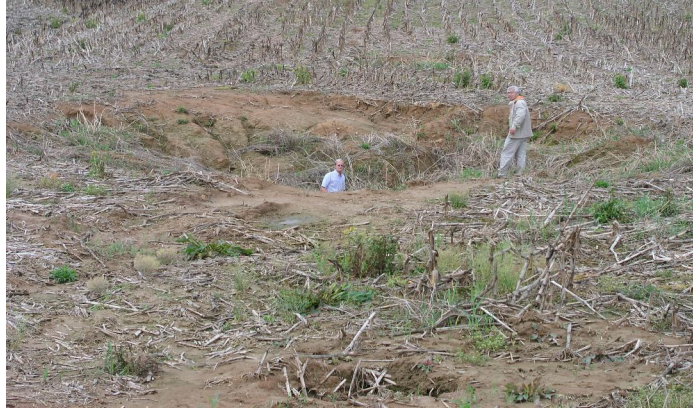
**Figure 6.** Photograph of sinkhole E on Linear 3 on the Newton farm.

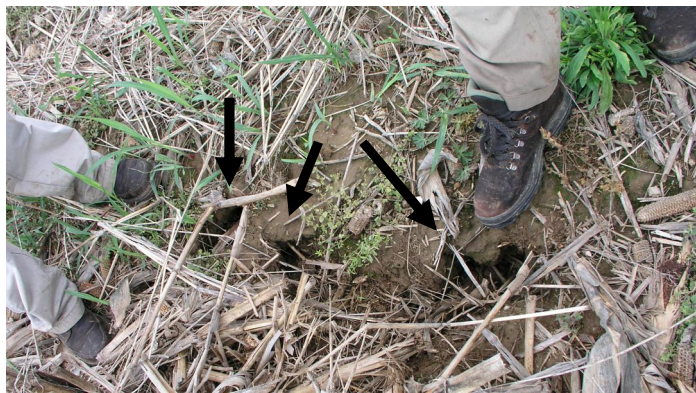
**Figure 7.** Photograph of epikarst swallow holes (indicated by arrows) along Linear 1 on the Newton farm.

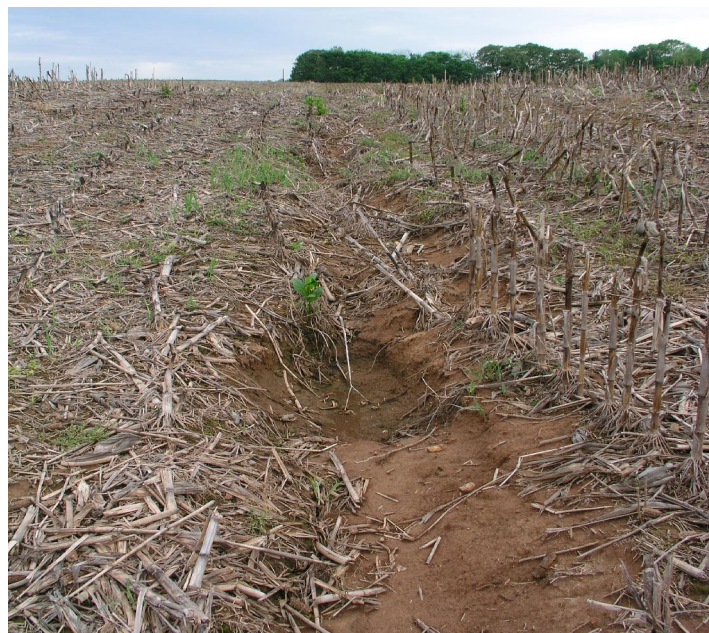
**Figure 8.** Photograph of the shallow erosion furrow with small knickpoint at mid-slope on Linear 2.

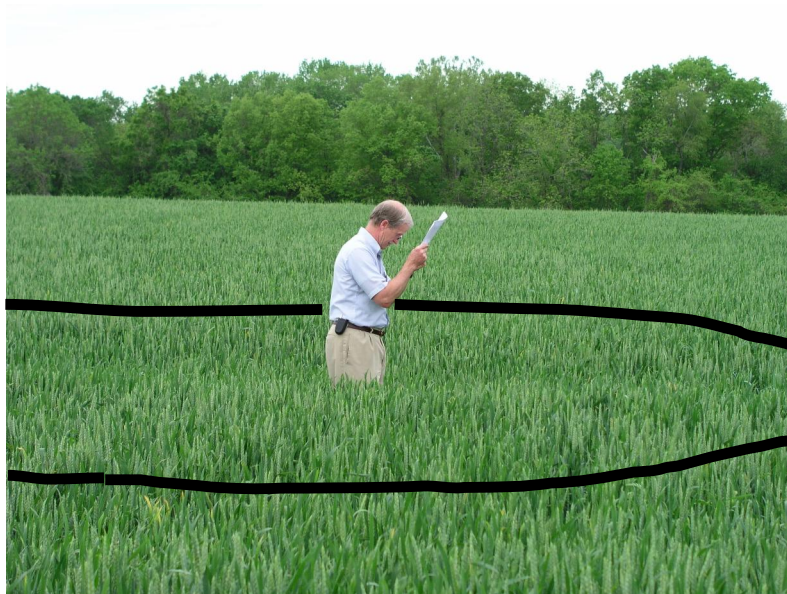
**Figure 10.** Photograph of Site 1 with an author standing within the area of stressed wheat as delineated by the black lines.

by the Crider silt loam on 2 to 6 and 6 to 12 percent slopes, and Pembroke-Crider on 6 to 12 percent slopes mapping units, with presence of Hammack Baxter Complex on 6 to 12 percent slopes and Linside silt loam mapping units. Similar to the Newton farm, Typic Paleudalfs dominate this area. In contrast to the Newton farm, no linears stand out on the photograph. However, there are light-green and bluish-green circular patterns that appear on the image scattered throughout the fields. Figures 9a, b and c, show the original, decorrelation-stretched and extracted feature layer of the River Bend Farm. The feature layer extracted from the processed image retains the same circular patterns as the original image. A field visit to this farm in April, 2006, found the fields in wheat approximately 1 m in height. Although difficult to walk through and to make observations because of the density and height of the wheat, several traverses were made into the fields to look for any evidence to suggest the cause for the circular patterns. At Site 1, a circular area of about 10 m in diameter, the wheat was approximately 0.6 m tall, noticeably stunted when compared to the wheat outside of this pattern (Figure 10).
